PROPERTY INSPECTION REPORT

Maffei Property Inspections

123 Main St

Date of Inspection: 7/18/2024

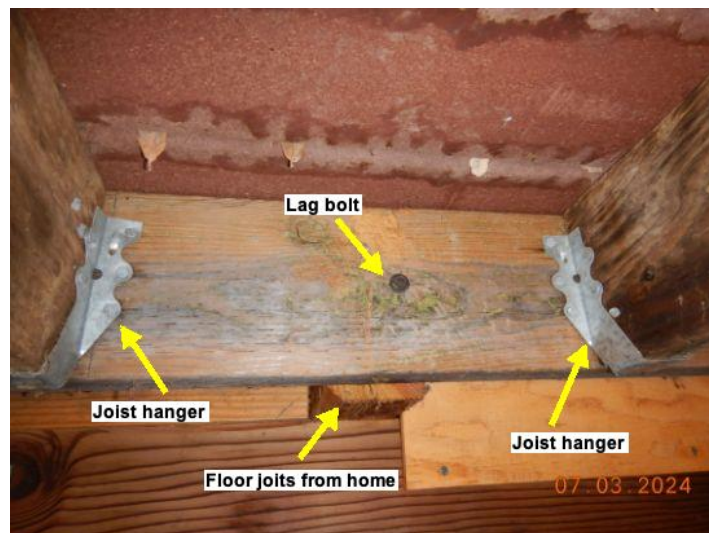
• On the north side of the master bedroom the floor joists of the deck were secured to a ledger board using hangers. However, the ledger board was attached to floor joist of the home with lag bolts that were screwed into the ends of the joist. Using hangers for this connection, as they were for the joists of the deck, would be a more secure connection.

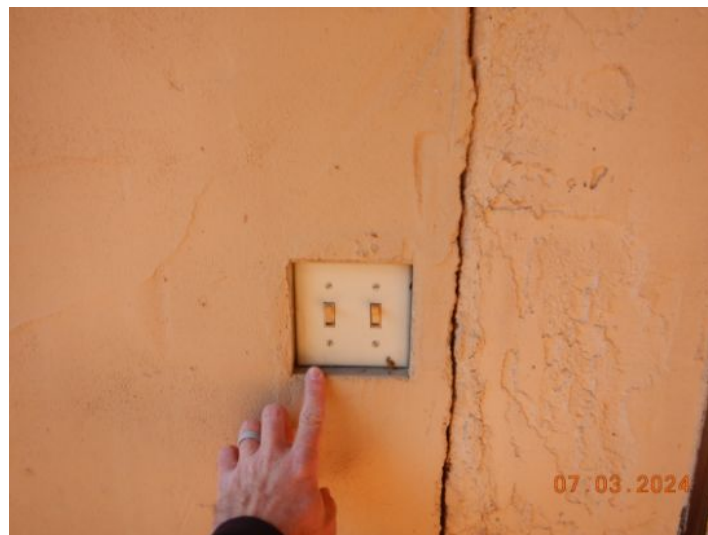
Outlets on front porch

- The switches on the front porch were not protected by a weather resistant cover.

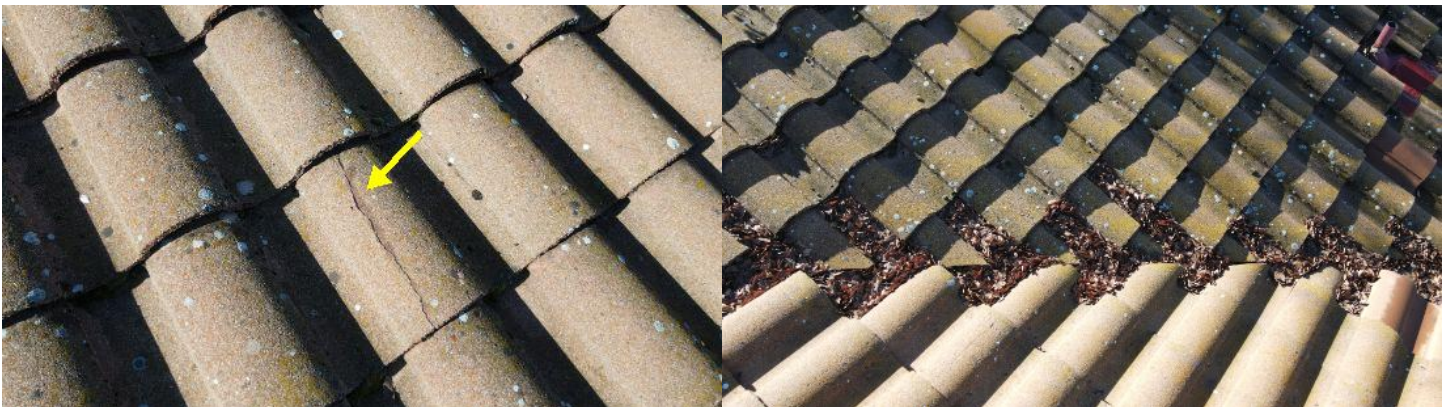
- Tree debris noted on the roof. This can lead to leaks, especially in the valleys.
- Cracked tiles noted over the garage. It was unclear if these cracks have been addressed. In other locations it appeared as though the cracks have been sealed, however, the sealant used may fail over time and need to be reapplied. Monitor.

Example of cracks in tiles

Example of tree debris in valley

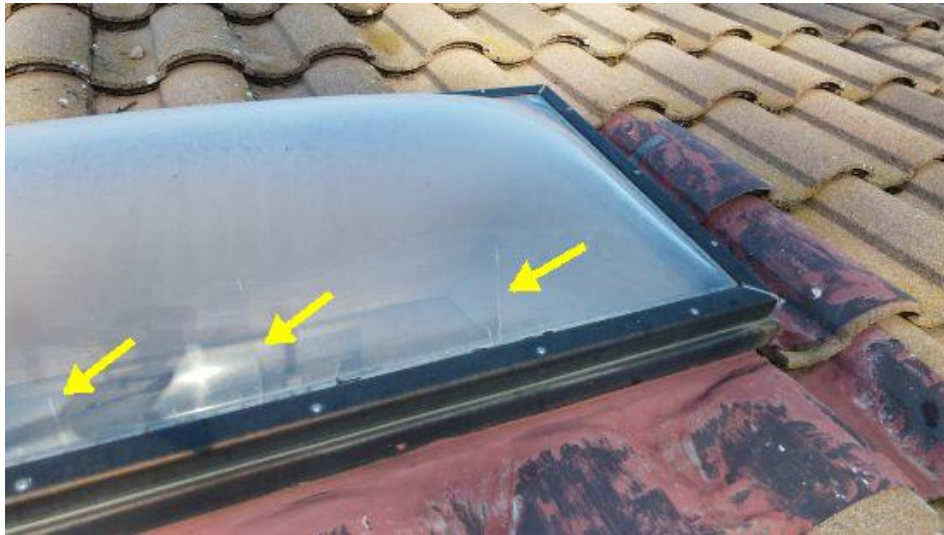
- Cracks noted in the lenses of the sky lights over the front patio.

Example of cracks in skylight lense

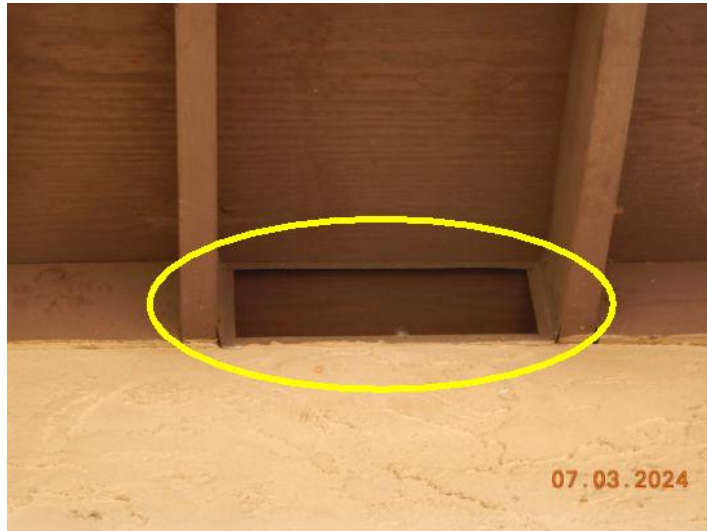
Example

- The screens over the soffit vents in the eaves of the garage were loose or missing.

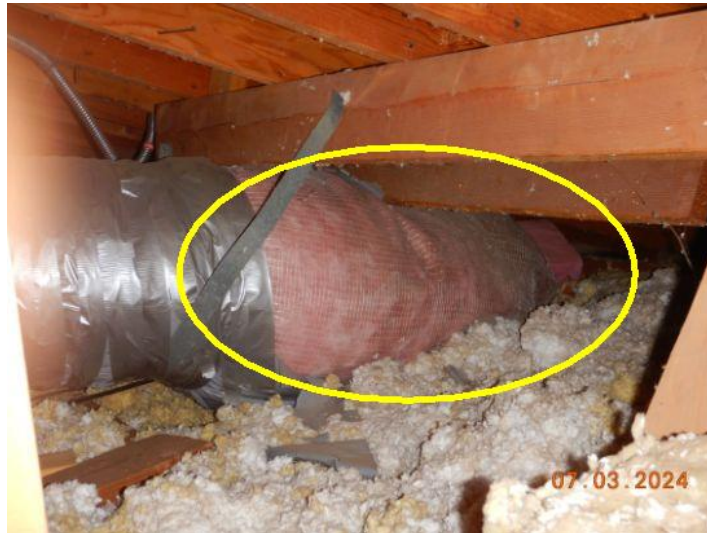
- The vapor barrier around the return ductwork over the west end of the hallway has torn.

Torn vapor barrier

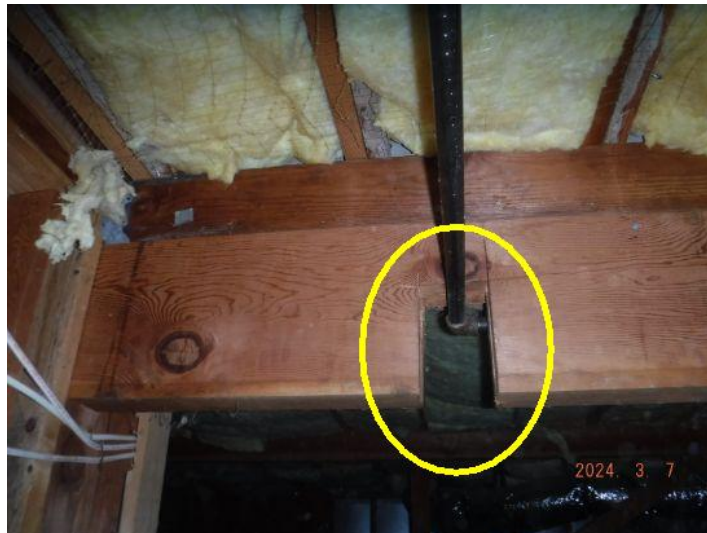
- A girder under the east hallway has been notched to make room for plumbing. There were two girders in this location. Only one was notched.

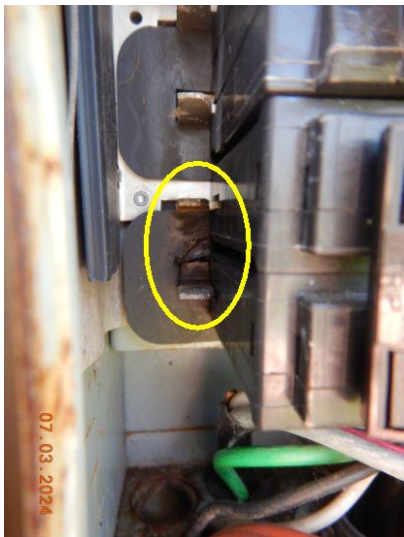
- Possible signs of overheating observed at the bottom of the main panel. The plastic behind the buss bar has melted
- When the main panel was viewed with an infrared camera the inspector observed a temperature anomaly at the quad 30amp/50amp, 2 pole breaker. This indicates overheating in this location. The circuits landed at this breaker were labeled "hot tub" and "pool panel".

Melted plastic

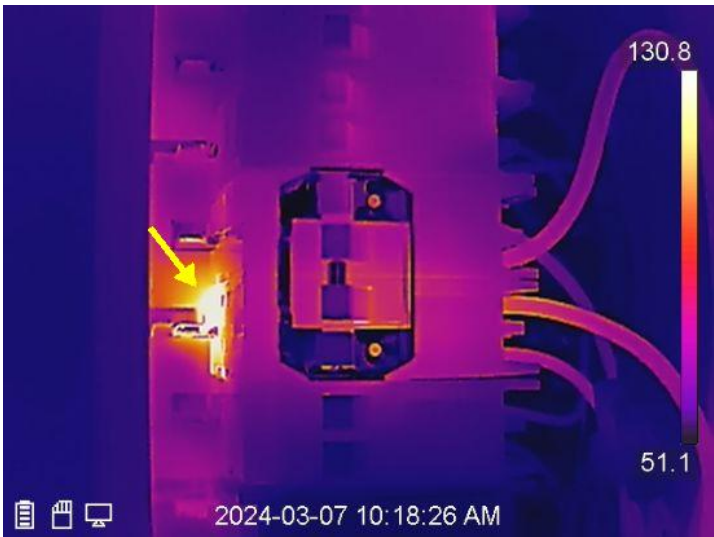
Temperature anomaly

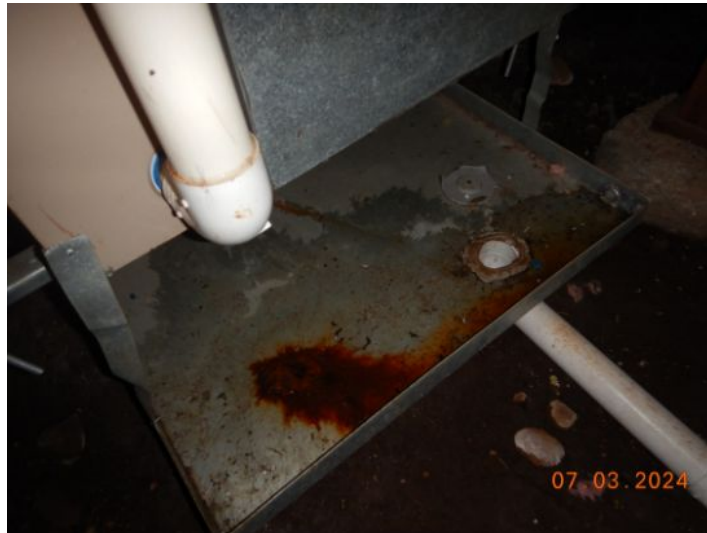
- Rust and moisture observed in the drip pan under the furnace in the crawlspac. There appeared to be an active condensation or moisture leak.

Rust and moisture in drip pan

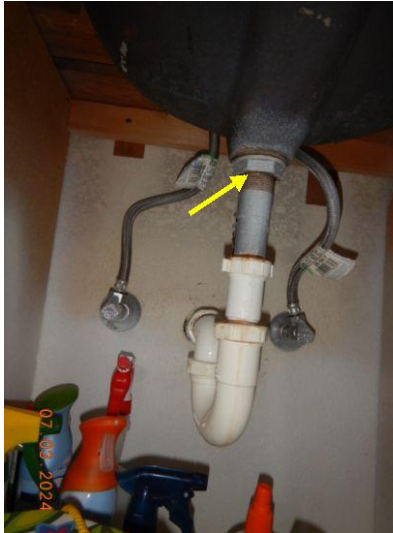
- Leak noted under the right sink in the Jack and Jill bathroom.
