3-D Home Inspection, Inc

Property Inspection Report

1023, Great Street, Best Town, IL 61112

Date of Inspection: 12/8/2021 Time: 09:00 AM

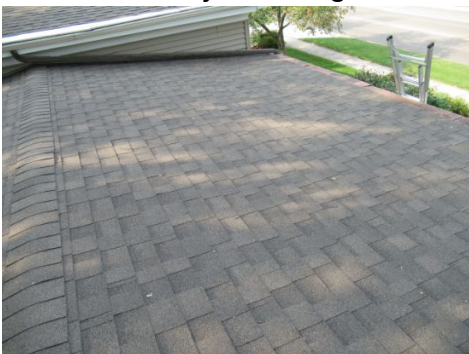
lower roof

- OK: No indications of significant deficiencies were observed during the inspection of the viewable areas. No major damage or missing shingles were observed.

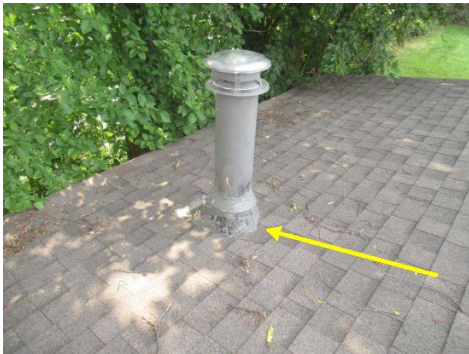
flashing>vent

- OK: No indications of significant deficiencies were observed during the inspection of the viewable areas.

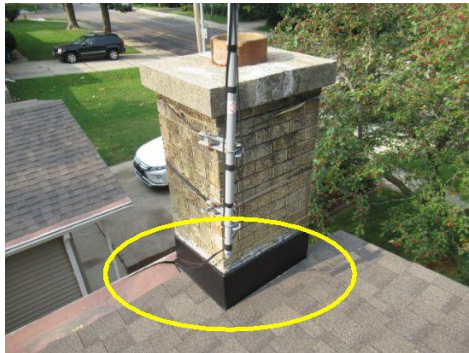
flashing>chimney

- OK: No indications of significant deficiencies were observed during the inspection of the viewable areas.

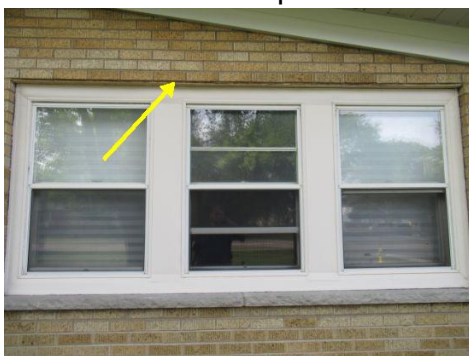
• **REPAIR / REPLACE:** **Lintels** are rusting. When steel rusts, it expands, and can lead to surrounding brick and mortar damage. Corrective action by a qualified mason is recommended.

lintel above window>rusted

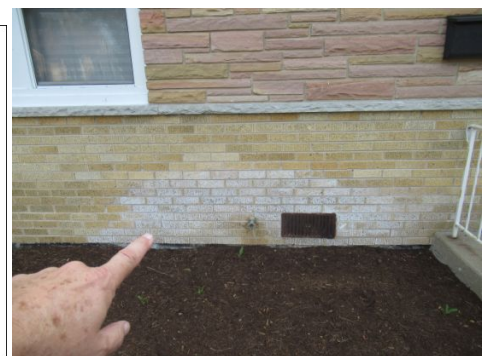
• **REPAIR / REPLACE:** **Efflorescence** was observed. This indicates water intrusion or other issue. The inspection could not determine if it is cosmetic or an indication of a larger problem. Corrective action by a qualified mason is recommended.

Efflorescence

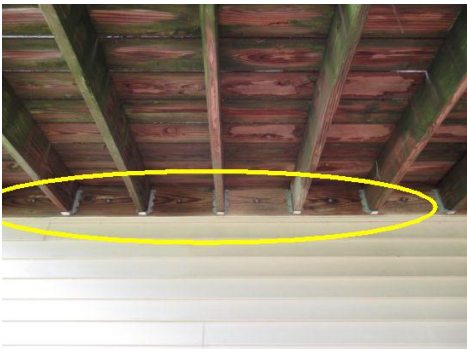
- REPAIR / REPLACE: The ledger board **flashing** is missing, improperly installed, or not visible. This can result in water **leaks** into the walls/house and increases the potential for deck collapse. Corrective action by a qualified, NADRA (North American Deck and Railing Association) certified, decking contractor is recommended.

- REPAIR / REPLACE: The ledger board does not appear properly attached to the building. Lag bolts are not spaced properly or end up in a straight line. In my opinion, this can result in a **ledger board failure** and a collapse. Corrective action by a qualified, NADRA (North American Deck and Railing Association) certified, decking contractor is recommended.

ledger board flashing not found / improper bolt pattern

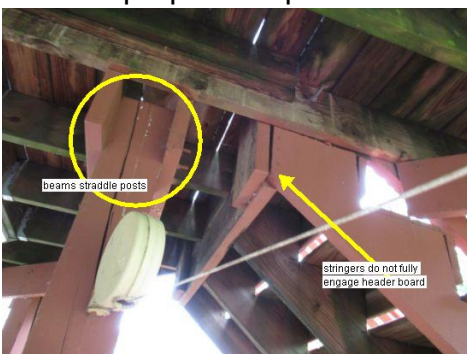
- REPAIR / REPLACE: Beams are relying on shear strength of bolts through the posts and not resting on top of posts and/or with proper fastening hardware. As **wood** ages, this connection is prone to failure. It is not possible to predict if or when failure will occur. There are special metal brackets designed to help support these beams. Corrective action by a qualified, NADRA (North American Deck and Railing Association) certified, decking contractor is recommended.

beams straddle posts

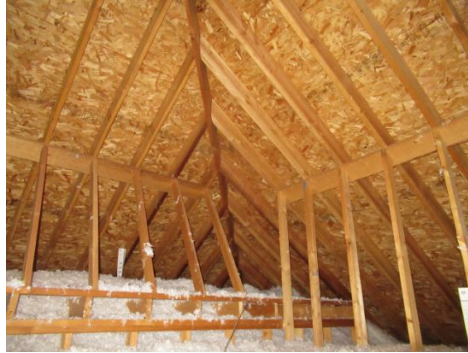
example of roof structure

- OK: No indications of significant deficiencies were observed during the inspection of the viewable areas. Viewing was limited.

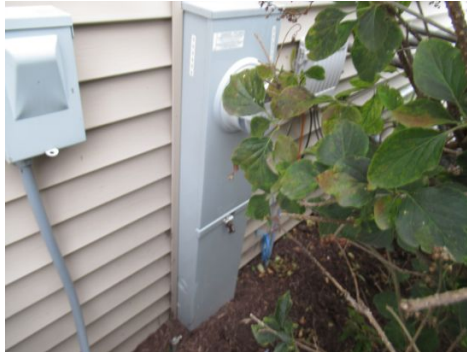
Service Entrance

- No indications of significant deficiencies were observed during the inspection.

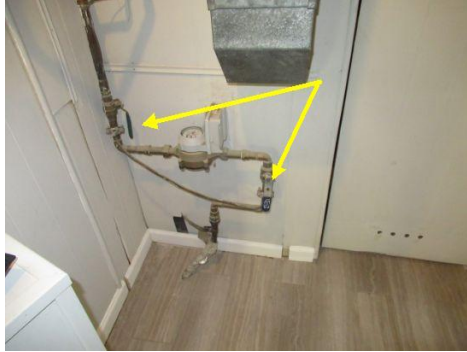
main water shut off valve / meter

- OK: No indications of significant deficiencies were observed during the inspection of the viewable areas.

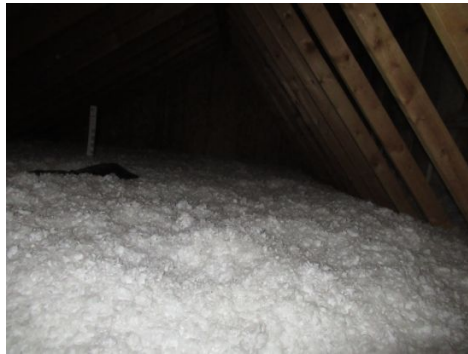
example of attic insulation

- OK: No indications of significant deficiencies were observed during the inspection of the viewable areas.
