# *3-D Home Inspection, Inc*

## Property Inspection Report

1023, Great Street, Best Town, IL 61112

Date of Inspection: 12/8/2021 Time: 09:00 AM

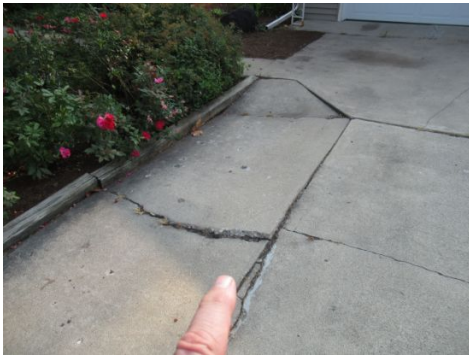
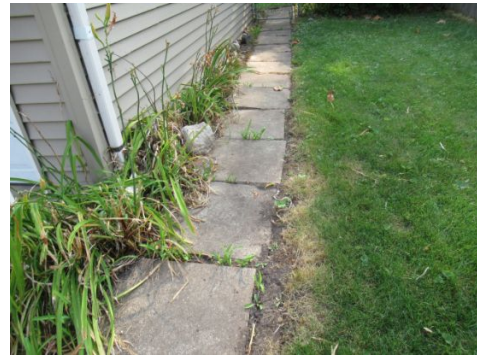
- **SAFETY:** Displacement, cracks, and uneven walking surfaces were observed. Uneven walking surfaces can lead to trips and falls if not corrected. **Corrective action** by a qualified contractor is recommended.

uneven walking surface

walkway>uneven walking surface

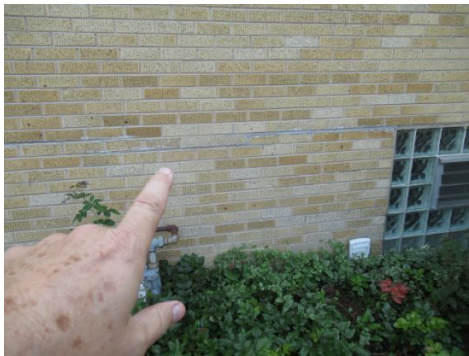
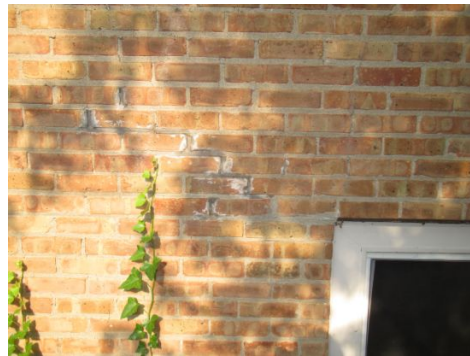
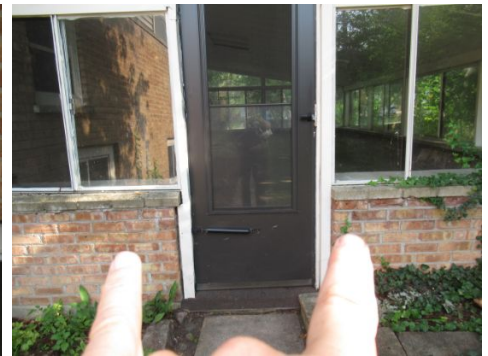
• **REPAIR / REPLACE:** Brick and mortar damage such as displacement and cracks were observed along with tuck pointing **repairs**. These suggest movement. Corrective action by a qualified mason is recommended.

- REPAIR / REPLACE: Brick and mortar damage such as displacement and cracks were observed along with tuck pointing **repairs**. These suggest movement. Corrective action by a qualified mason is recommended.
- REPAIR / REPLACE: **Lintels** are rusting. When steel rusts, it expands, and can lead to surrounding brick and mortar damage. Corrective action by a qualified mason is recommended.
- REPAIR / REPLACE: **Efflorescence** was observed. This indicates water intrusion or other issue. The inspection could not determine if it is cosmetic or an indication of a larger problem. Corrective action by a qualified mason is recommended.

mortar repair

mortar repairs

brick/mortar failure

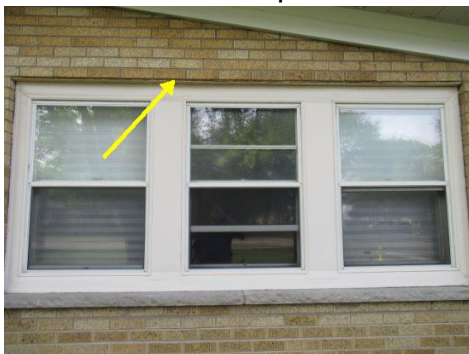
• **REPAIR / REPLACE:** **Lintels** are rusting. When steel rusts, it expands, and can lead to surrounding brick and mortar damage. Corrective action by a qualified mason is recommended.

lintel above window &gt; rusted

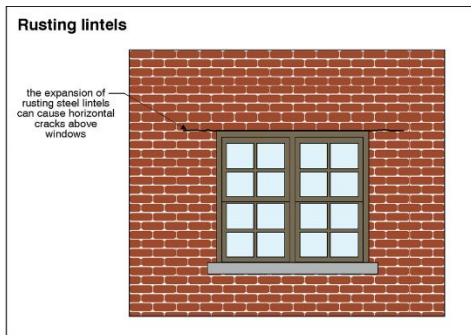
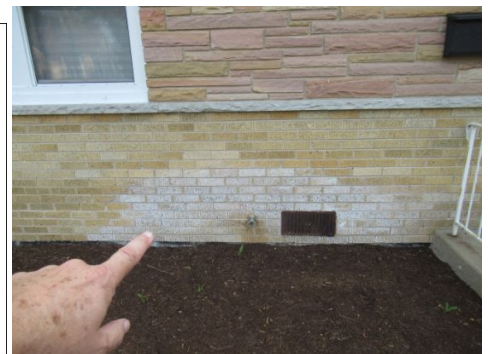
• **REPAIR / REPLACE:** **Efflorescence** was observed. This indicates water intrusion or other issue. The inspection could not determine if it is cosmetic or an indication of a larger problem. Corrective action by a qualified mason is recommended.

Efflorescence

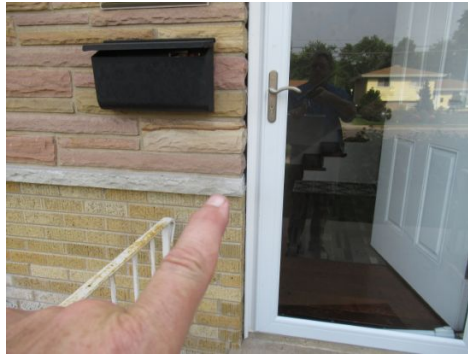
- REPAIR / REPLACE: **Caulk failure** and/or flashing defects were observed at one or more areas. This may be allowing water leaks or insect/rodent intrusion. the condition of the underlying materials is unknown. Corrective action by a qualified contractor is recommended.

flashing/caulk not finished

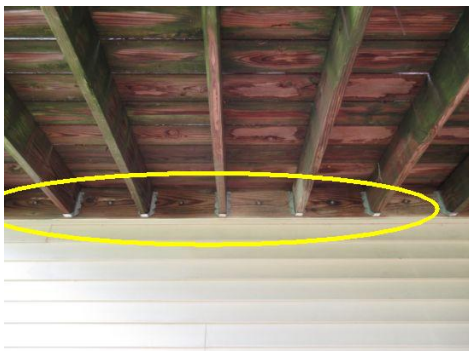
- REPAIR / REPLACE: The ledger board **flashing** is missing, improperly installed, or not visible. This can result in water **leaks** into the walls/house and increases the potential for deck collapse. Corrective action by a qualified, NADRA (North American Deck and Railing Association) certified, decking contractor is recommended.

- REPAIR / REPLACE: The ledger board does not appear properly attached to the building. Lag bolts are not spaced properly or end up in a straight line. In my opinion, this can result in a **ledger board failure** and a collapse. Corrective action by a qualified, NADRA (North American Deck and Railing Association) certified, decking contractor is recommended.

ledger board flashing not found / improper bolt pattern

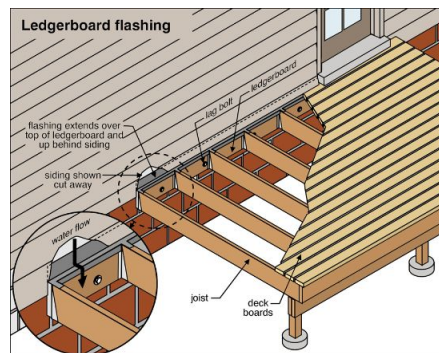
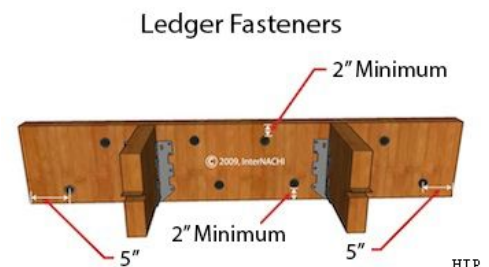
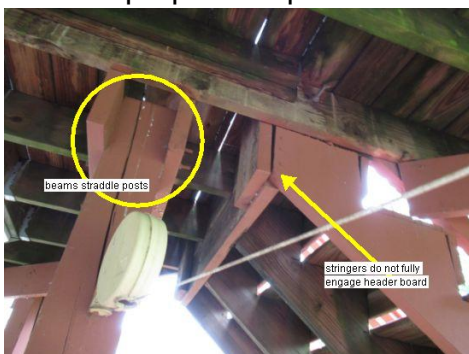
- REPAIR / REPLACE: Beams are relying on shear strength of bolts through the posts and not resting on top of posts and/or with proper fastening hardware. As **wood** ages, this connection is prone to failure. It is not possible to predict if or when failure will occur. There are special metal brackets designed to help support these beams. Corrective action by a qualified, NADRA (North American Deck and Railing Association) certified, decking contractor is recommended.

beams straddle posts

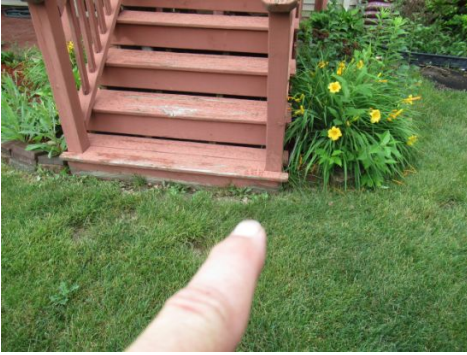
- REPAIR / REPLACE: The stringers are not properly supported by a header board, the bottom of the stringers are not on a proper landing or footing support. This increases the potential for failure that can lead to falls or injury. Corrective action by a qualified, NADRA (North American Deck and Railing Association) certified, decking contractor is recommended.

- **REPAIR / REPLACE:** The stringers are not properly supported by a header board, the bottom of the stringers are not on a proper landing or footing support. This increases the potential for failure that can lead to falls or injury. Corrective action by a qualified, NADRA (North American Deck and Railing Association) certified, decking contractor is recommended.

stingers not on solid surface

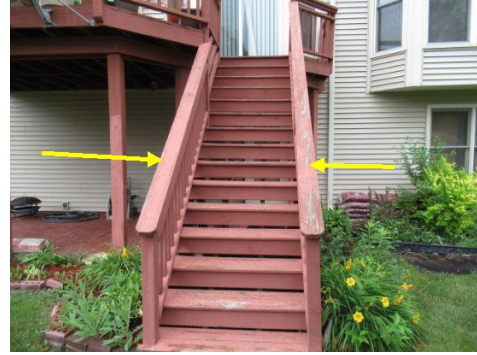
guarding not graspable

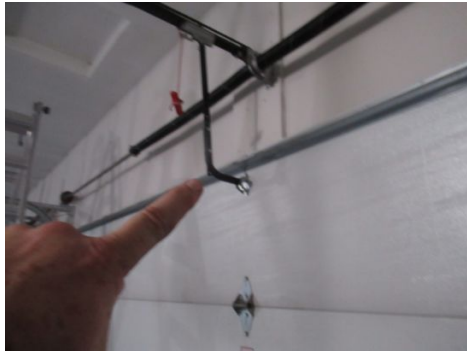
- **REPAIR / REPLACE:** There is no reinforcement bracket. These help to prevent the arm of the automatic door operator from pulling out of the door that can lead to damage. Corrective action by a qualified garage door contractor is recommended.

no reinforcing bracket for arm extension

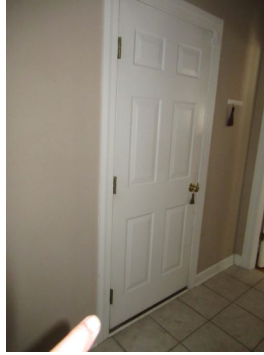
- **REPAIR / REPLACE:** The door into the house has no automatic door closure hinges or mechanism. Based on today's best building practices a properly working door closing mechanism helps to provide **garage and house separation** for fire and fumes. Corrective action by a qualified carpenter is recommended.

no door closing hinges

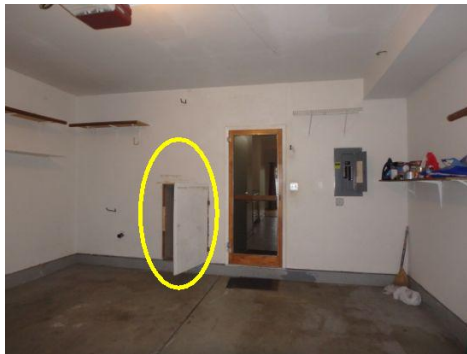
- REPAIR / REPLACE: The fire separation wall has been altered. This can allow the easy spread of fire from the garage into the house. Corrective action by a qualified carpenter is recommended.

- **REPAIR / REPLACE:** The fire separation wall has been altered. This can allow the easy spread of fire from the garage into the house. Corrective action by a qualified carpenter is recommended.

breach in the fire separation wall

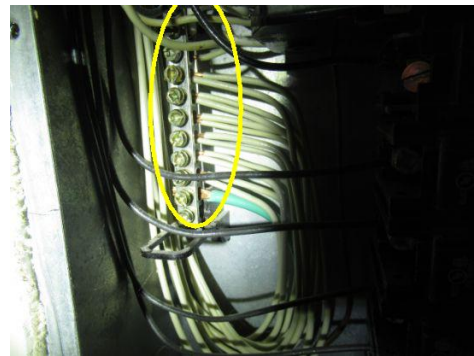
- SAFETY: One or more lugs in the neutral bus bar contain two or more conductors (wires) commonly called **double tap**. Typically, lugs are not designed for more than one wire. Wires can overheat or work loose creating arch & fire hazards. Two or more neutral wires under the same lug can lead to circuit isolation hazards under certain conditions. Although this is a common trade practice or was allowed at one time, it is not technically correct as prescribed by the manufacturer. Corrective action by a qualified electrician is recommended.

- **SAFETY:** One or more lugs in the neutral bus bar contain two or more conductors (wires) commonly called **double tap**. Typically, lugs are not designed for more than one wire. Wires can overheat or work loose creating arch & fire hazards. Two or more neutral wires under the same lug can lead to circuit isolation hazards under certain conditions. Although this is a common trade practice or was allowed at one time, it is not technically correct as prescribed by the manufacturer. Corrective action by a qualified electrician is recommended.

neutral bus bar > **double taps**

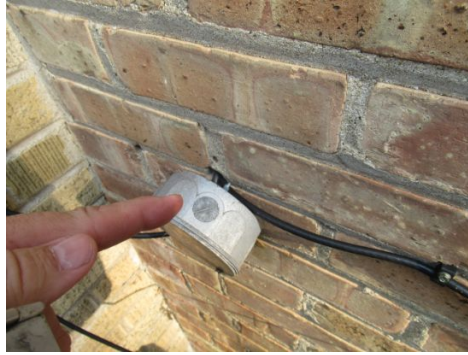
- **REPAIR / REPLACE:** Distribution wiring at one or more locations is not properly or reasonably protected. These are prone to mechanical damage which can lead to shock or fire hazards. Corrective action by a qualified electrician is recommended.

loose junction box/exposed wiring

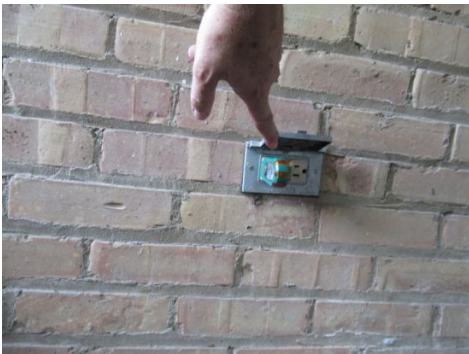
- **SAFETY:** One or more receptacles did not properly respond to **GFCI** testing or GFCI protection is not installed at certain locations as prescribed by today's best building practice. This increases the potential for shock and electrocution hazards. Corrective action by a qualified electrician is recommended.

Receptacle did not respond to GFCI testing

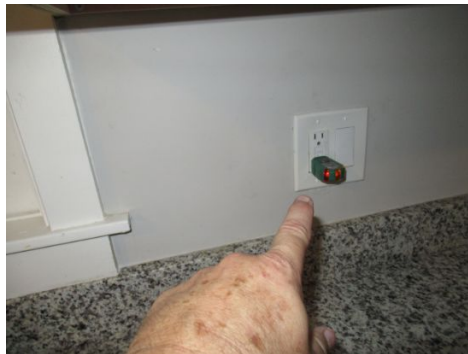
- **SAFETY:** Of the representative sampling of receptacles tested, certain receptacles read on the test meter to be 'open or bad ground' / 'open neutral' / or 'reverse polarity' / or did not have power. This is considered to be improperly wired and a shock, electrocution, or fire hazard. Corrective action by a qualified electrician is recommended.

receptacle&gt;reversed polarity

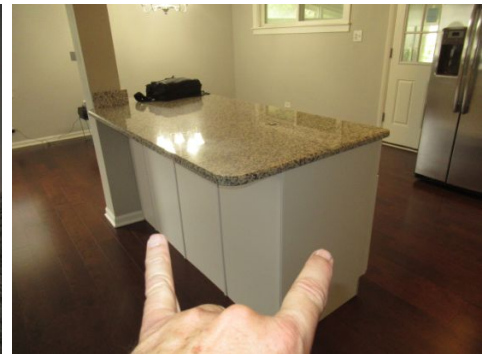
no receptacles at kitchen island

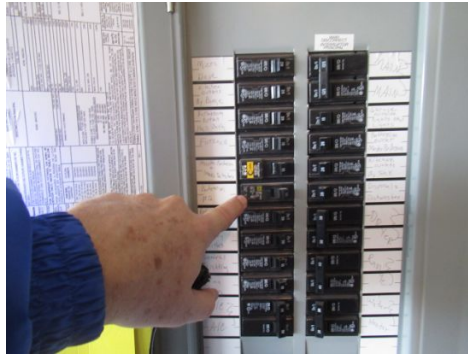
- **SAFETY:** One or more circuit breakers are not from the same manufacturer as the electrical panel. This is commonly called **mixed breakers**. This poses certain fire hazards if they do not seat properly as required by the panel's manufacturer. Corrective action by a qualified electrician is recommended.

mixed breaker / not AFCI

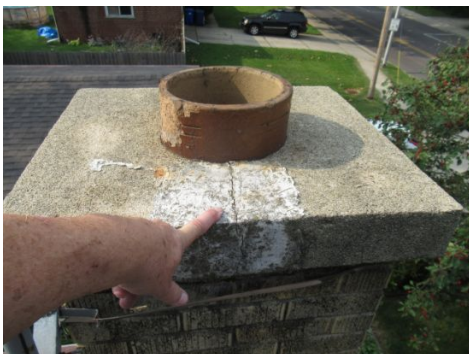
- **REPAIR / REPLACE:** The crown cap is damaged, cracked, or does not properly overhang the chimney's sides. This may allow water to enter and damage the brick, **flue** and chimney or other building and finish materials. Corrective action by a qualified **CSIA** certified, Chimney Sweep is recommended.

crown>cracked

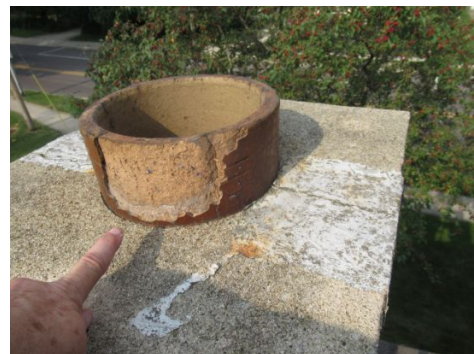
- **SAFETY:** The furnace is mid-efficient with its vent pipe connector routed into a masonry chimney. Mid-efficiency furnaces requires an appropriate metal flue liner (preferably stainless steel as aluminum will deteriorate within a short time). As much as I can see, the chimney is not equipped with a metal flue liner. A lack of an appropriate metal liner can result in liner / chimney deterioration and other flue gas related problems. Corrective action by a qualified CSIA (Chimney Safety Institute of America) certified, mason contractor is recommended.

- **REPAIR / REPLACE:** There is no rain cap. This helps to keeps water, birds, animals out of the building and in the case of a wood burning fireplace, prevents sparks from escaping. Although not required, one is recommended. Corrective action by a qualified CSIA certified, Chimney Sweep is recommended.

liner damage / no rain cap

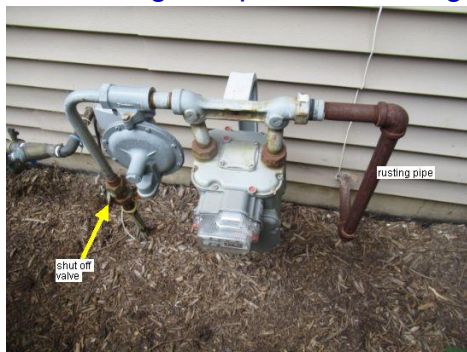
- **REPAIR / REPLACE:** There is rust on the pipe going into the house from the gas meter. This side of the meter is the homeowners' responsibility. Corrective action by a qualified plumber is recommended to help prevent further rusting and possible damage or gas leaks.

Main gas shut off valve/rusting pipe

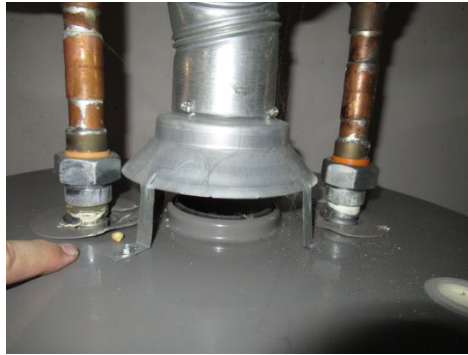
• **SAFETY:** The plastic escutcheon rings on top of the water heater are melted. This indicates past or intermittent **spillage** of exhaust gases commonly called **backdrafting**. Exhaust gases potentially contain **carbon monoxide** or other harmful gases. This can be caused by poor draft, blocks in the flue, or negative pressures caused by **mechanical fans** in the house. Corrective action by a qualified plumber is recommended.

- **SAFETY:** The plastic escutcheon rings on top of the water heater are melted. This indicates past or intermittent spillage of exhaust gases commonly called **backdrafting**. Exhaust gases potentially contain carbon monoxide or other harmful gases. This can be caused by poor draft, blocks in the flue, or negative pressures caused by **mechanical fans** in the house. Corrective action by a qualified plumber is recommended.

melted escutcheon rings

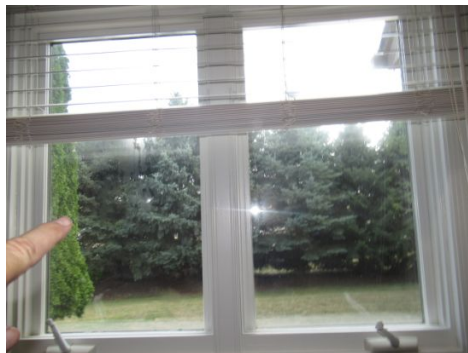
• **REPAIR / REPLACE:** Windows in one or more rooms have visual indicators of fogging, condensation streaks or droplets, desiccant beads, cracked glass, or rust between glass panes. This is often referred to as a 'blown seal'. Windows with **blown seals** no longer retains their insulating value. There may be more windows but not noticeable due to fogging that comes and goes. The windows are nearing the end of their life expectancy. Repairs will help to extend their life but you should expect to replace one or more in each of the upcoming years. Consultation with a qualified window contractor is recommended to determine the scope to repair or replace the windows.

- **REPAIR / REPLACE:** Windows in one or more rooms have visual indicators of fogging, condensation streaks or droplets, desiccant beads, cracked glass, or rust between glass panes. This is often referred to as a 'blown seal'. Windows with **blown seals** no longer retains their insulating value. There may be more windows but not noticeable due to fogging that comes and goes. The windows are nearing the end of their life expectancy. Repairs will help to extend their life but you should expect to replace one or more in each of the upcoming years. Consultation with a qualified window contractor is recommended to determine the scope to repair or replace the windows.

condensation between glass panels

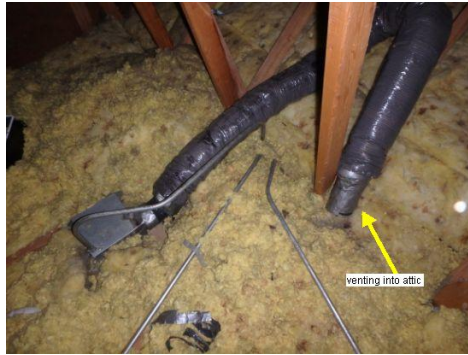
• **REPAIR / REPLACE:** Ducts for one or more mechanical fans terminate in the attic such as a roof or soffit vent, or directly into the attic. Terminating inside an attic adds considerable **moisture** which can lead to condensation, rot, or potentially mold. This is most likely reason for the rusted roofing nail tips. Best building practice is for mechanical vent termination to be to the outside with a vent jack. Corrective action by a qualified insulation and ventilation contractor is recommended.

- **REPAIR / REPLACE:** Ducts for one or more mechanical fans terminate in the attic such as a roof or soffit vent, or directly into the attic. Terminating inside an attic adds considerable moisture which can lead to condensation, rot, or potentially mold. This is most likely reason for the rusted roofing nail tips. Best building practice is for mechanical vent termination to be to the outside with a vent jack. Corrective action by a qualified insulation and ventilation contractor is recommended.

bathroom duct laying on attic floor
