PROPERTY INSPECTION REPORT

Maffei Property Inspections

123 Main St

Date of Inspection: 7/18/2024

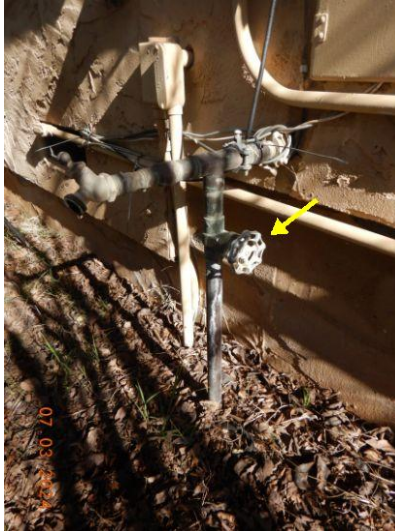
Main water shutoff

- Appeared functional at time of inspection.
- Main water shut off was located at the southwest corner of the home.

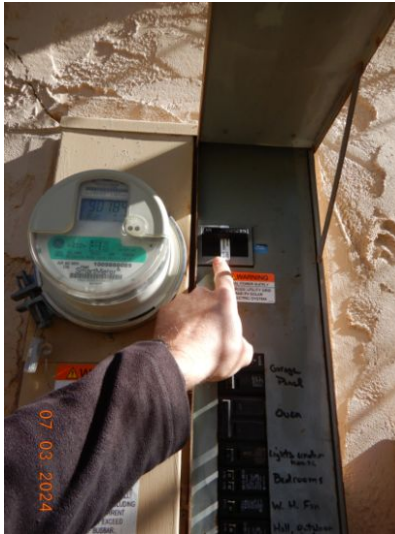
Main breaker

- Appeared functional at time of inspection.
- The garage subpanel was inaccessible due to personal property.

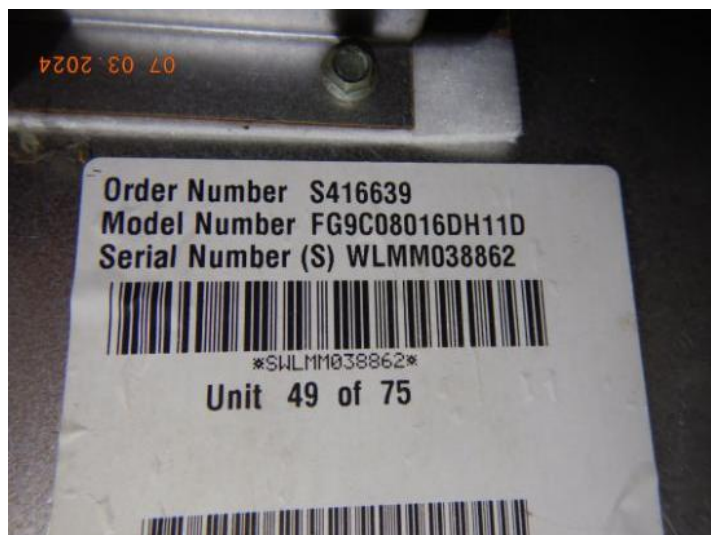
Crawlspac furnace

- The air handler for the heat pump was manufactured in 2013. The furnace in the crawlspac appeared to be original to the home.
- The air handler for the heat pump was manufactured in 2013. The furnace in the crawlspac appeared to be original to the home.
- The furnace in the crawlspac uses propane to heat. The drip pan under the furnace will also catch propane leaks. The large 2" drain line is intended to transport the propane gas out of the crawlspac. However, in this case the 2" line did not exit the crawlspac.

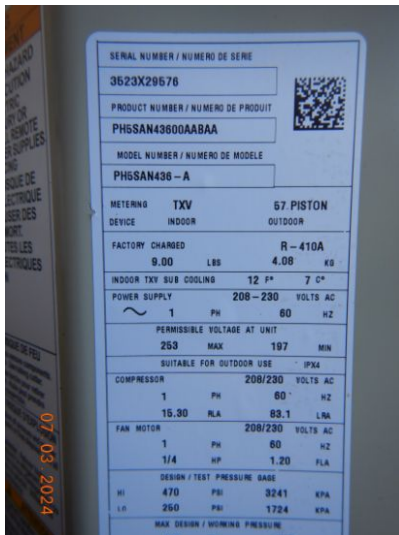
BDP unit

- Because outside temperature was less than 65 degrees fahrenheit the AC was not tested.
- Make: York(west side of home, manufactured in the early to mid 1908's)
- Make: BDP (north side of home, manufactured around 2023)

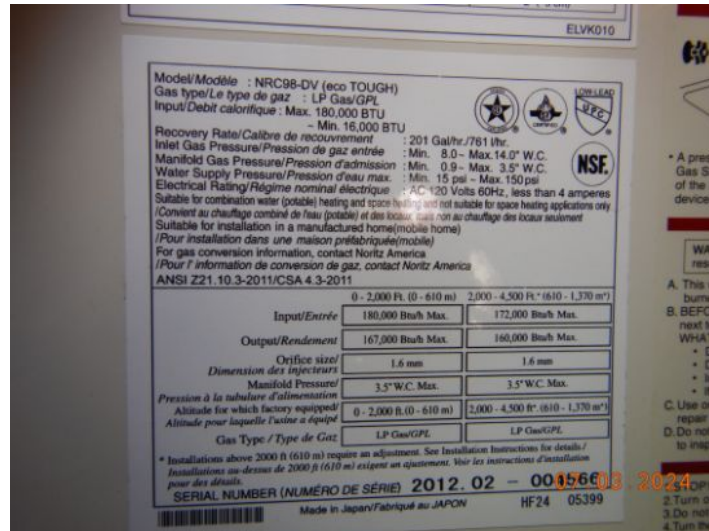
Main breaker

- Appeared functional at time of inspection.
- Make: Noritz (manufactured between around 2012)
